LONG TERM CARE HOME FEASIBILITY STUDY

SUN PARLOR HOME

175 TALBOT STREET EAST, LEAMINGTON, ONTARIO

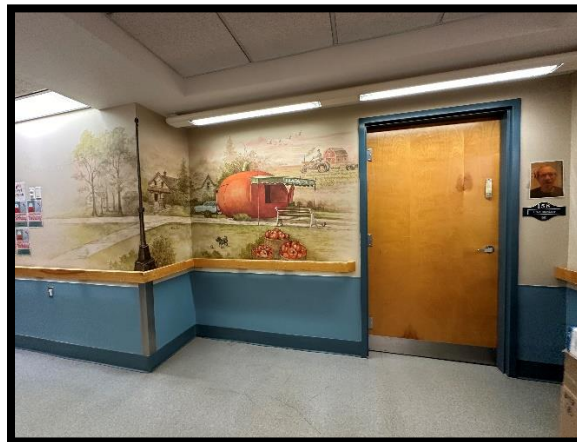
Photo 1: Typical resident bedroom door.

- All resident housing areas, except in the original wing, have bedroom doors that are less than the minimum width of 1120mm (44in.). They typically have an opening of 40". The width of the doors in the original wing surpasses the required 40".
- To comply with the Design Standards, remediation may include:
 - Demolition of partition wall.
 - Installation of new doorway.
 - Installation and paint of new gypsum board over the open areas of the wall.
 - New trim around the doorway.
 - Installation of the new door.
 - Reinstallation of the signage.
- The general cost for the project scope is estimated at \$845,000 for the replacement of 153 resident room doors.

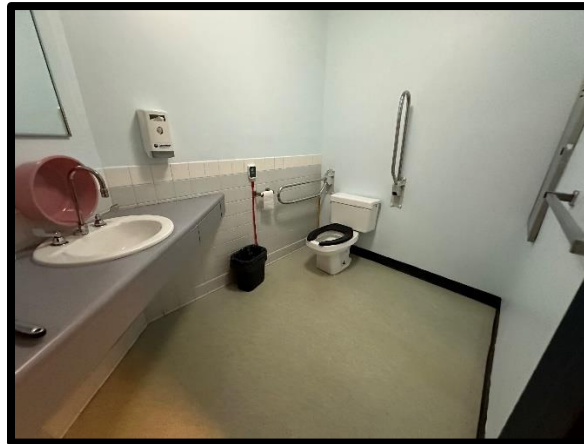
Photo 2: Typical resident washroom.

- None of the resident washrooms have a 1.524 m (5ft) turning circle. The turning circle is measured from the edge of the toilet seat and from the edge of the countertop/sink. However, the Design Variance Standard states that “the turning circle may go underneath the toilet and the sink but the amount of space that can be measured underneath the toilet and sink will be limited to the depth of the wheelchair pedals/footrests. It does not include the space all the way to the walls where the toilet and sink hang”.
 - With this exception, the washrooms have a 1.524 m (5ft) turning circle, so no changes need to be made.
-

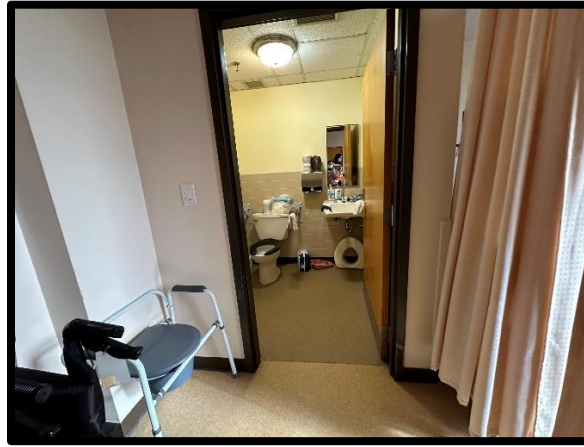
Photo 3: Typical resident washroom door.

- Most entrance widths do not meet the minimum 914 mm (3 ft.). They typically have an opening of 787 mm (2.6 ft).
 - To comply with the Design Standards, remediation may include:
 - Demolition of partition wall.
 - Installation of the new doorway.
 - Installation and painting of new gypsum board over the open areas of the wall.
 - New trim around the doorway.
 - Installation of the track and brackets.
 - Installation of a folding door. The door must shut completely to ensure resident privacy. The door must glide easily for resident use.
-

- Attaching the hardware. Ensure door handles are easy to grip (“C” or “D” type handles) and located on the door so that hands and knuckles will not be hit when opening and shutting the door.
- The general cost for the project scope is estimated at \$980,000 for expanding the doorways and installation of 178 new doors.

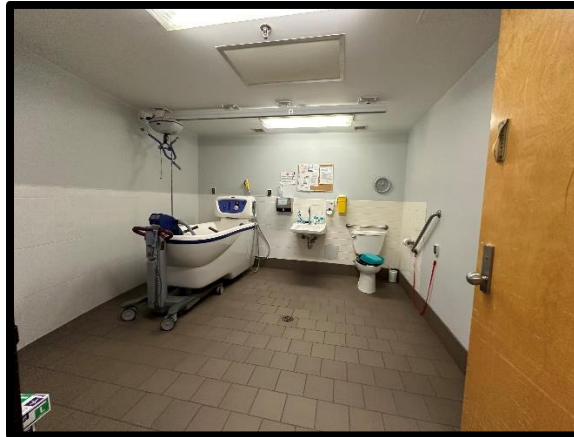
Photo 4: Typical resident bathroom.

- Resident bathrooms and shower rooms typically have direct view of the bathtub, shower, and/or toilet from the corridor.
 - To comply with the Design Standards, remediation may include:
 - Preparation of the ceiling for privacy curtain.
 - Installation of ceiling mounts.
 - Installation of curtain tracks to create a “vestibule” within the space.
 - Securing and adjusting the tracks.
 - Installation of curtains.
 - The general cost for the project scope is estimated at \$7,500 for the installation of 15 curtains.
-

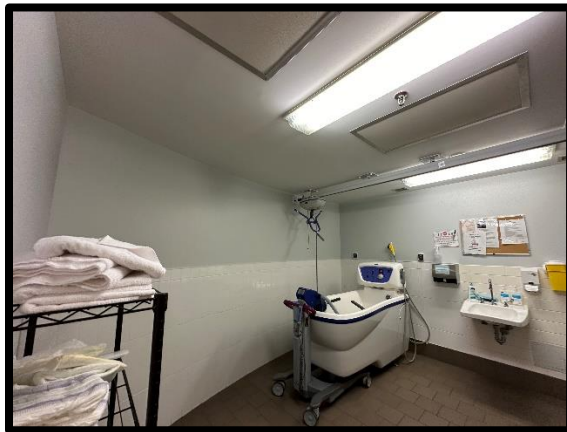
Photo 5: Typical resident bathroom with radiant ceiling.

- Resident bathrooms and shower rooms are not typically equipped with an independently controlled thermostat. However, all bathroom and shower rooms are equipped with radiant ceiling heat. The radiant ceiling allows the staff to increase to room temperature while the resident is bathing or showering. No action is required.

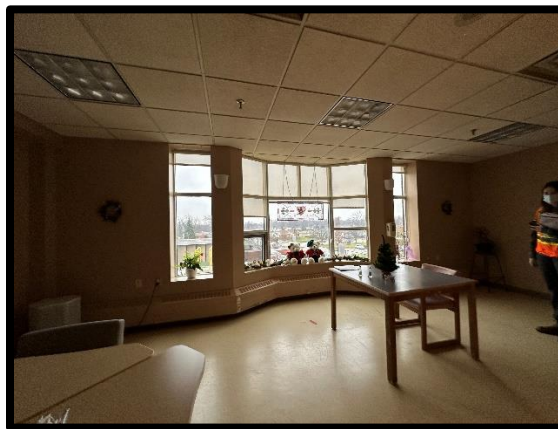
Photo 6: Typical resident lounge and program/activity space.

- The building does not have at least 70 percent of the required resident lounge and program/activity space for each RHA located in the RHA. However, when applying the Design Standard Variance of 1.95 sq.m. (21 sq.ft.) of floor area per resident, it exceeds this percentage. Refer to Table 2.

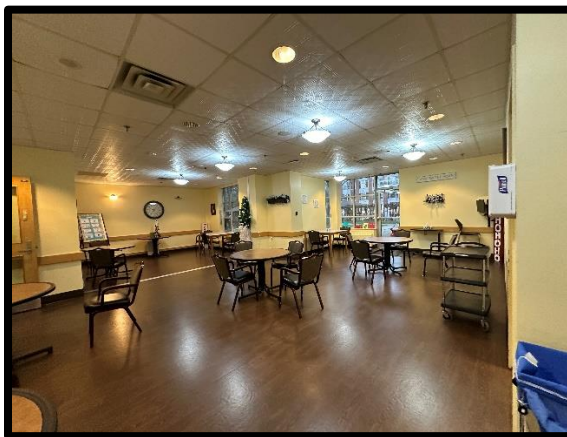
Photo 7: Typical resident dining area.

- 100 percent of the required space for dining areas is not located within the RHA. However, the Design Variance Standard states that “up to 30 per cent of the total required space for dining may be located outside the RHAs. These areas must provide the applicable requirements for meal service (e.g., the provision of three meals per day, including alternates/choices, diet types, etc).”. So, when applying the Design Standard Variance 2.32 sq.m. (25 sq.ft.) of floor area per resident it exceeds this percentage. Refer to Table 3.

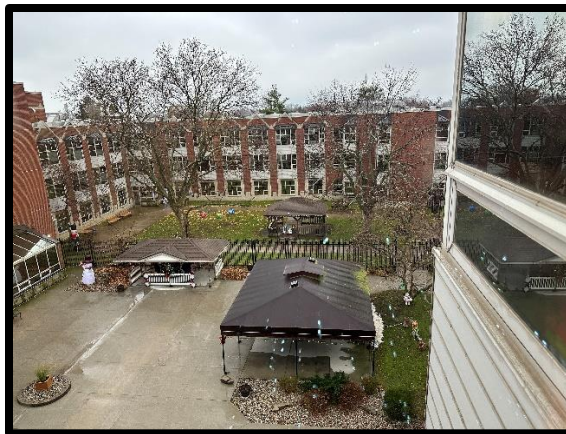
Photo 8: Courtyard access to all residents.

- Outdoor space is not provided on every floor where there is an RHA. However, the Design Variance Standard states that residents must have access to adequate outdoor space. As access is available via the rear courtyard area, there are no recommendations for remediation.
-

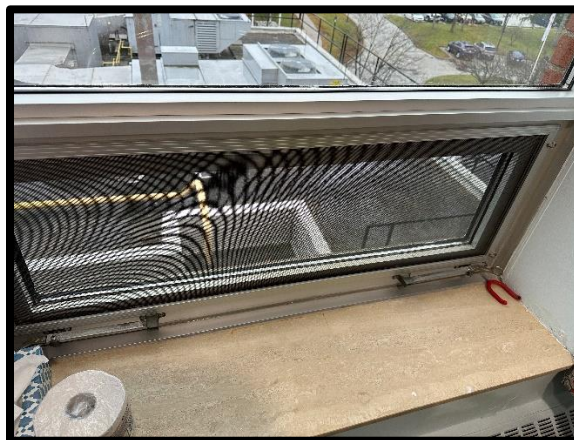
Photo 9: Typical window.

- Every window where residents have access are not operable. The windows are bolted shut.
 - To comply with the Design Standards, the windows should be replaced to allow for 15 cm openings.
 - The replacement year and costs for the windows has been included in the BCA portion of the report. New windows can include limiters which will control the size of the openings.
-

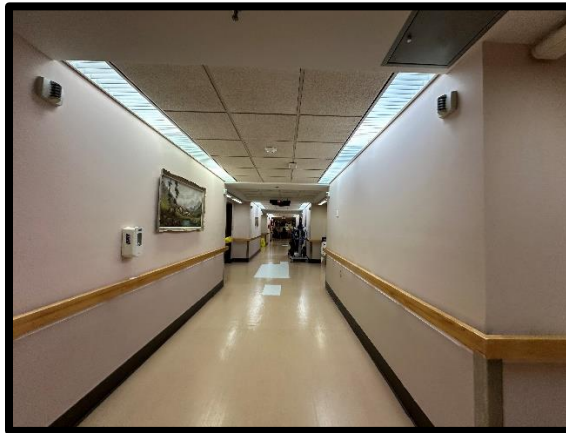
Photo 10: Typical lighting in corridor.

- Lighting levels were captured in each corridor. The average lux level recorded was 212 lux, which does not meet the standard.
 - To comply with the Design Standards, remediation may include:
-

- Replacing existing or adding light fixtures.
- The general cost for the project scope is estimated at \$105,000 in order to achieve the required lux level.

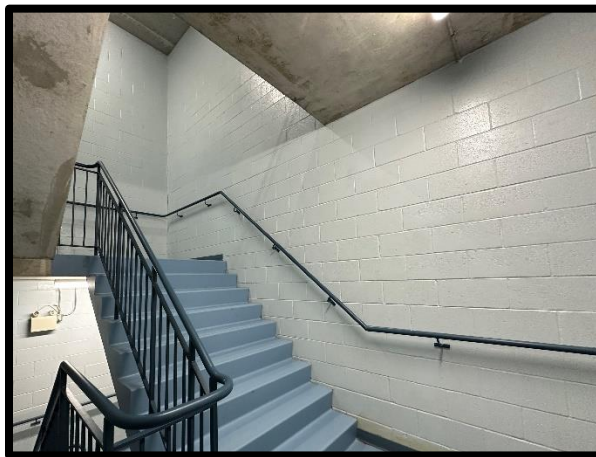
Photo 11: Typical lighting in stairwell.

- Lighting levels were captured in all stairwells. The average lux level recorded was 230 lux, which does not meet the standard.
 - To comply with the Design Standards, remediation may include:
 - Replacing existing or adding light fixtures.
 - The general cost for the project scope is estimated at \$30,000 to achieve the required lux level.
-

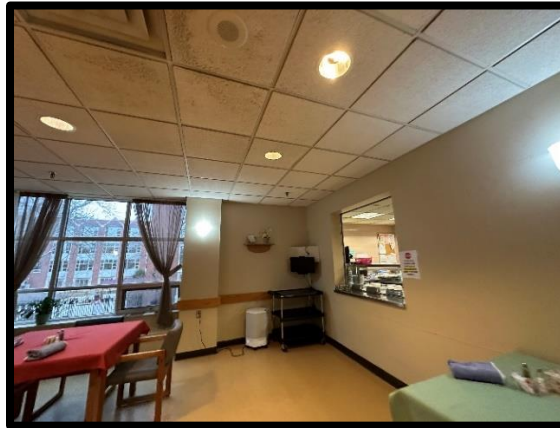
Photo 12: Typical lighting in common spaces.

- Lighting levels were captured in all other resident areas of the home. The average lux level recorded was 93 lux, which does not meet the standard.
 - To comply with the Design Standards, remediation may include:
 - Replacing existing or adding light fixtures.
 - The general cost for the project scope is estimated at \$390,000 to achieve the required lux level.
-

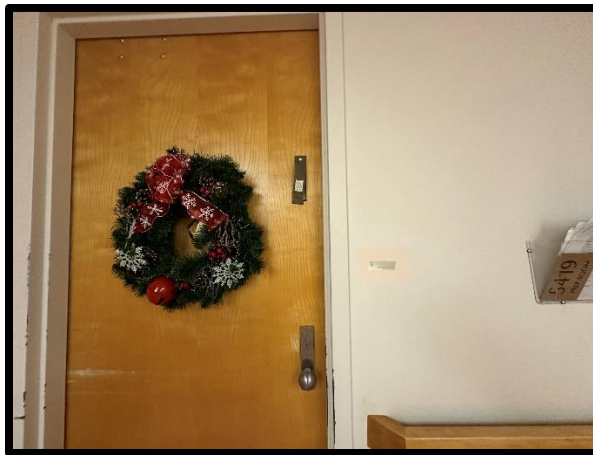
Photo 6: Missing signage for room.

- Signage is missing for the Prep Room on the fourth floor.
- To comply with the Design Standards, remediation may include:
 - Fixing or replacing existing gypsum board where signage was located.
 - Painting gypsum board.
 - Installing new signage.
- The general cost for the project scope is estimated at \$250 for reinstalling the signage.

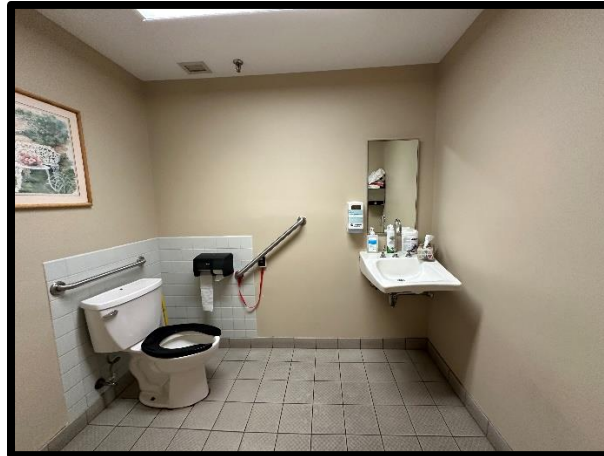
Photo 6: Typical public washrooms.

- The majority of entrance widths do not meet the minimum requirement of 914 mm (3 ft.). They typically have an opening of 787 mm (2.6 ft). In addition, these public washrooms are not labelled as accessible and do not have a push plate button for automatic door operators.
 - To comply with the Design Standards, remediation may include:
 - Removal of the old sink.
 - Adjustment of the plumbing to reroute or extend piping to the same wall as the toilet.
 - Preparation of the new wall for the new sink.
 - Installation of the new sink.
 - Demolition of partition wall.
 - Installation of new doorway.
 - Installation of powered openers.
-

- Most public washrooms do not have a 1.524 m (5ft) turning circle.
 - Refer to 10.7.3 for a detailed explanation on the installation and cost to relocate the sink.
-

- Installation and painting of new gypsum board over the open areas of the wall.
 - Installation of new push plate.
 - Installation of trim around new doorway.
 - Installation of new door.
 - Installation of new signage that includes ADA Wheelchair Symbol.
- The general cost for the project scope is estimated at \$270,000 for 9 public washrooms.
