BUILDING CONDITION ASSESSMENT FOR  
COUNTY OF ESSEX

**SUN PARLOR LONG TERM CARE  
HOME**

**175 TALBOT STREET EAST, LEAMINGTON**

REPORT DATE: May 29, 2024

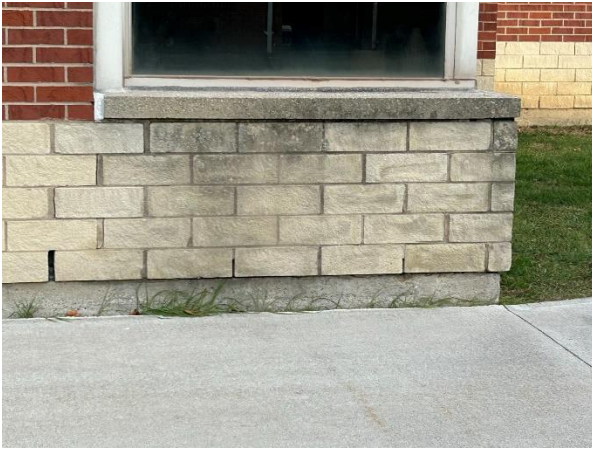
The building is partially clad in a stone veneer. The veneer is in generally in fair condition. Spalled and deteriorated joints were noted at the base of the bay windows. It is likely due to poor water shedding detailing.

**Photograph No. 5** Stone deterioration and staining below lower-level windows.

An allowance is included for localized repair and replacement of the stone veneer. It is recommended to time work with other exterior work to take advantage of economy of scale.

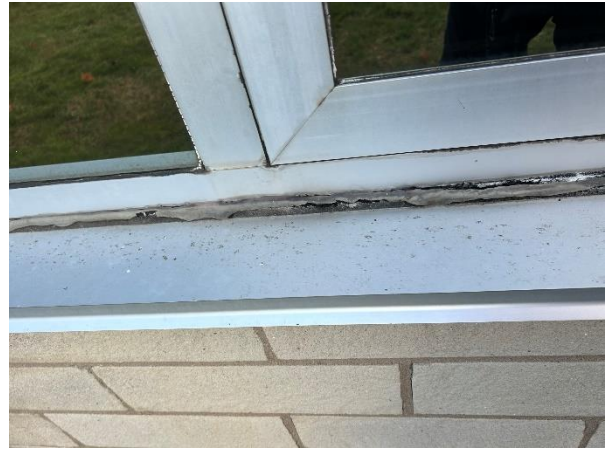
Exterior sealants around doors and windows were generally noted to be in fair to poor condition. The windows have also been face-sealed in response to previous water leakage issues. The sealants along masonry details and some window perimeters are in poor condition with cracked/split sections noted throughout. Sealants should be replaced to prevent water and air leakage into the building.

**Photograph No. 6** Failed caulking at window perimeter.

An allowance is included for replacement of the Exterior Sealants at the end of their expected service life.

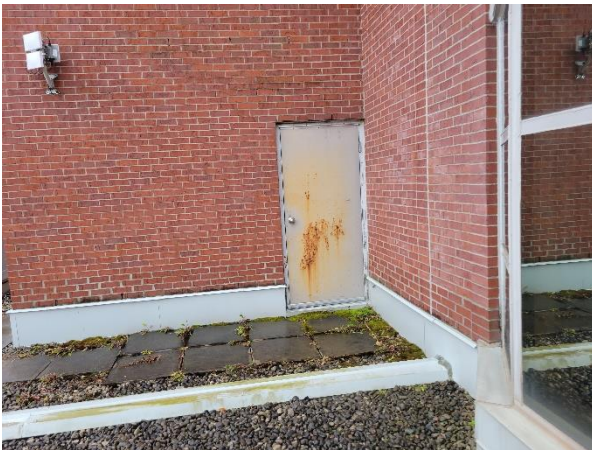
The lower roof access door is in poor condition with physical damage and corrosion observed. The door also has difficulties closing.

**Photograph No. 7** Corroded lower roof access door.

Allow to replace the door in the short term.

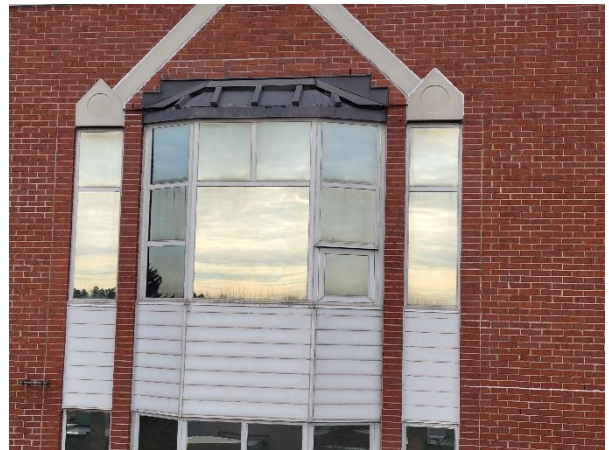
**Photograph No. 8** Failed window film at the bay windows.

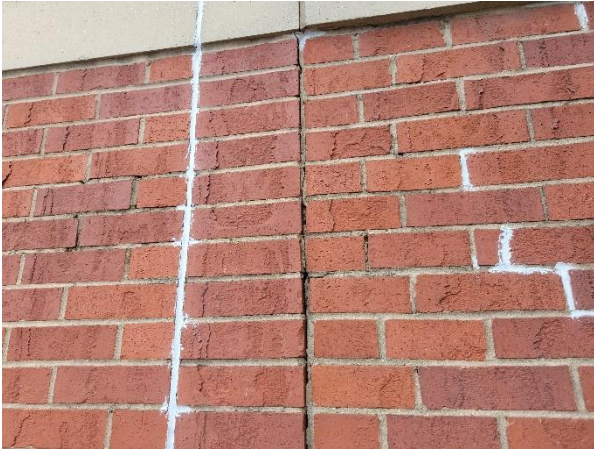
The building is partially clad in a brick veneer. The veneer is in generally in good to fair condition. There are areas of spalling and efflorescence throughout the building.

**Photograph No. 9** Failed expansion joints at brick veneer.

An allowance is included for localized repair and replacement of the brick veneer. It is recommended to time work with other exterior work to take advantage of economy of scale.

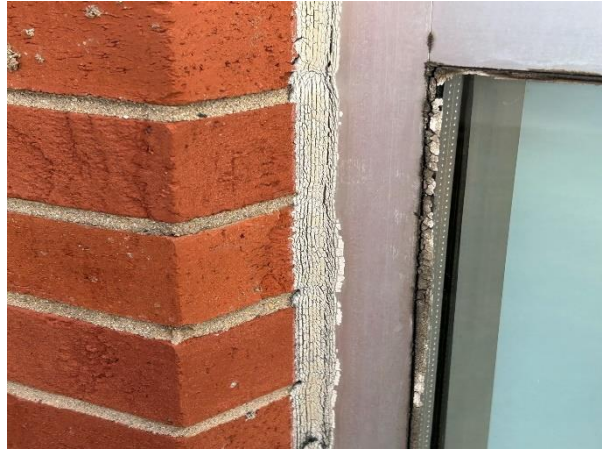
**Photograph No. 10** Aged Sealant around windows

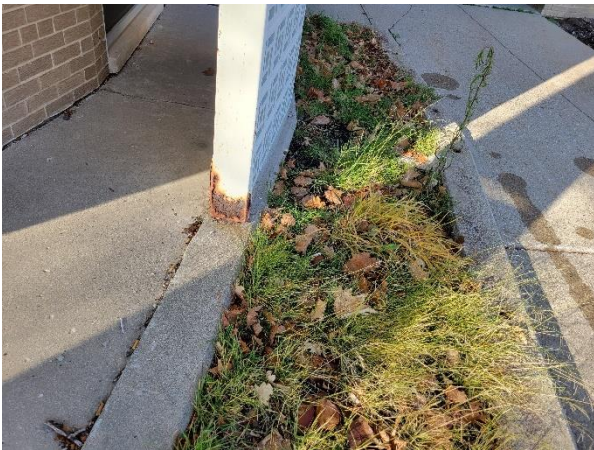
The chapel is surrounded by decorative precast concrete screens in metal framing. The screens are in good condition however, the metal framing is corroded along the base.

**Photograph No. 11** Corroded metal framing at decorative screens.

It is recommended the screens be repainted and excessively corroded sections be repaired in the short term.

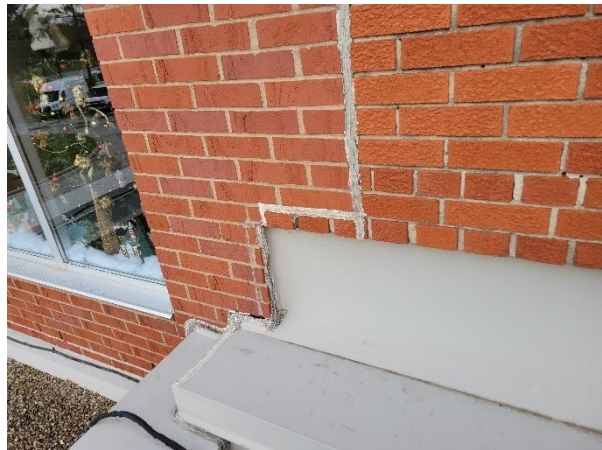
**Photograph No. 12** Brick generally in good condition at south and main wings.

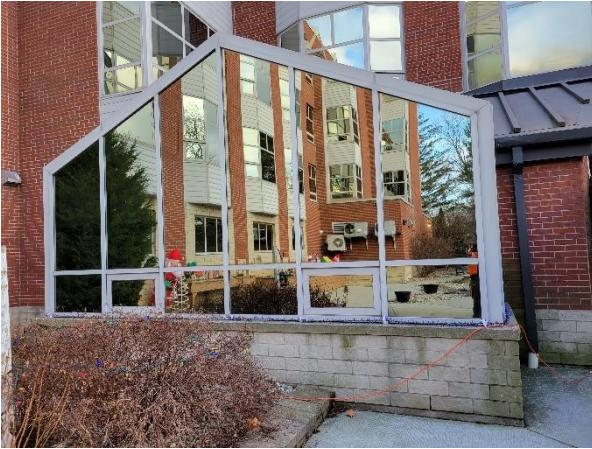
**Photograph No. 13** Windows frames are generally in good condition.

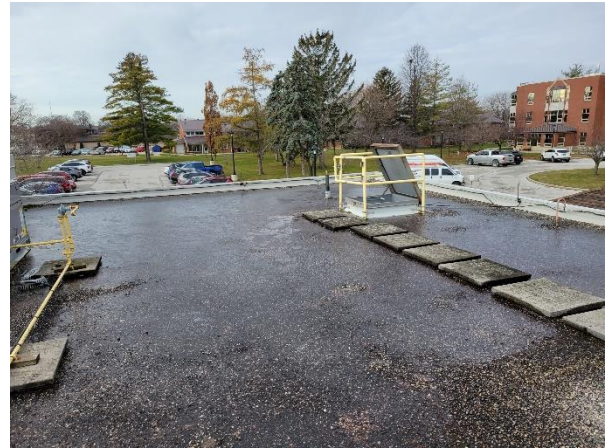
The south wing roofs are clad in built-up roofing systems (BUR) with prefinished metal perimeter flashings and area drains. Maintenance walkways are provided throughout the roofs. Ponding water and ice were noted throughout, indicating inadequate slope in some areas. Some asphalt bleed outs were noted with some minor repairs noted at

**Photograph No. 16** Ponding water along south roof areas.

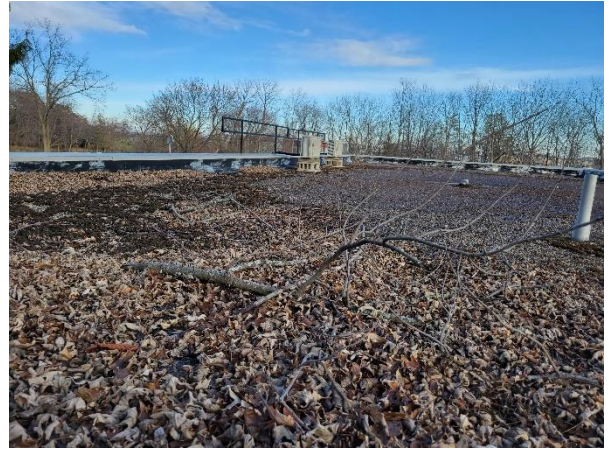
The garage roof is clad in a built-up roofing system (BUR) with prefinished metal perimeter flashings and area drains. are provided throughout the roofs. Significant vegetation was noted on the roof, with area drain appearing to be blocked. There were no signs of active water leakage in the areas review. No major issues were reported. It is our understanding the roof was installed circa 2003.

**Photograph No. 18** Buildup of vegetation on garage roof.

Due to the age of the roof, it is expected that the roof will require replacement in the short term.

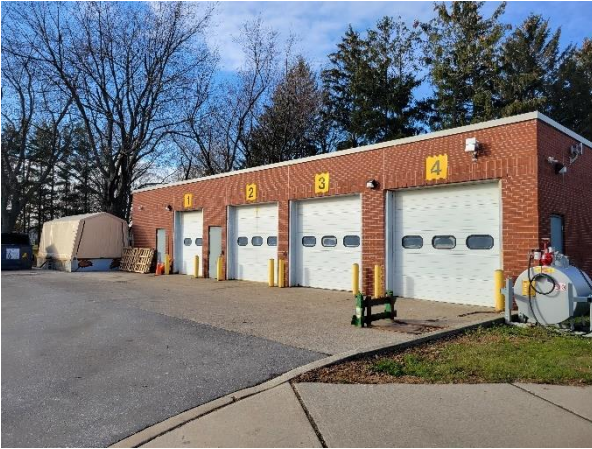
**Photograph No. 21** Overhead garage doors are in good condition.

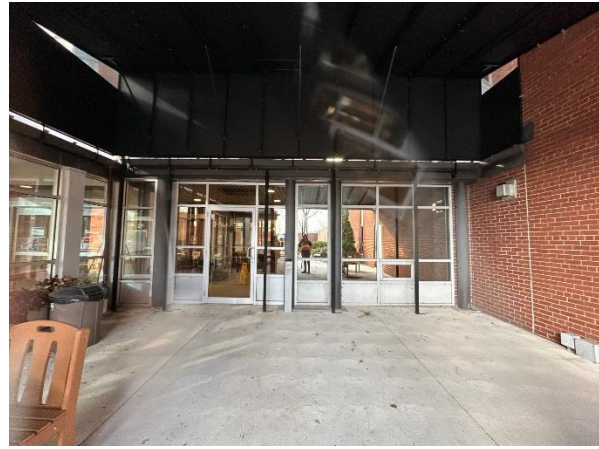
**Photograph No. 22** Glazed entrance doors are in good condition.

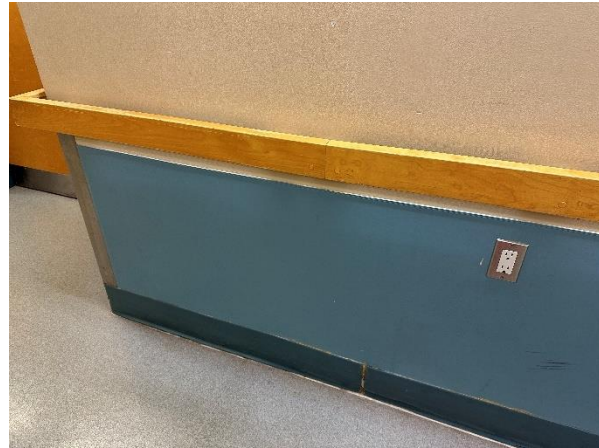
**Photograph No. 24** Faded wood handrails.

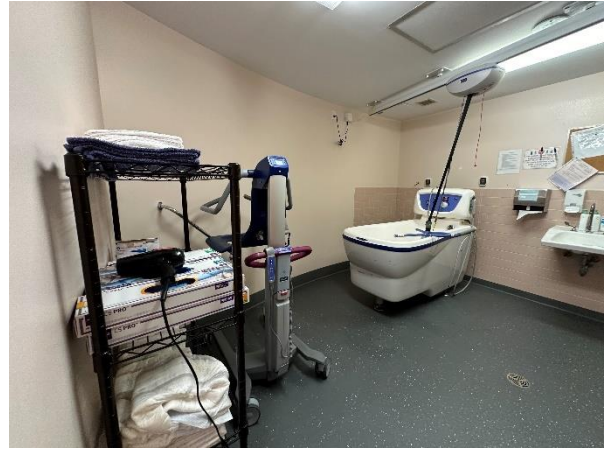
**Photograph No. 30** Typical shower and tub room finishes are in good to fair condition.

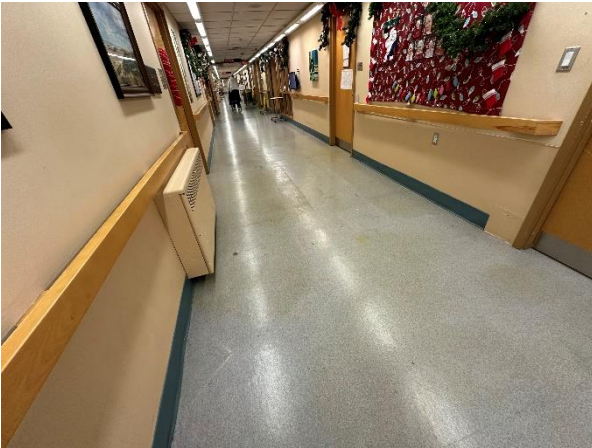
**Photograph No. 35** South wing corridor finishes are generally in fair condition.

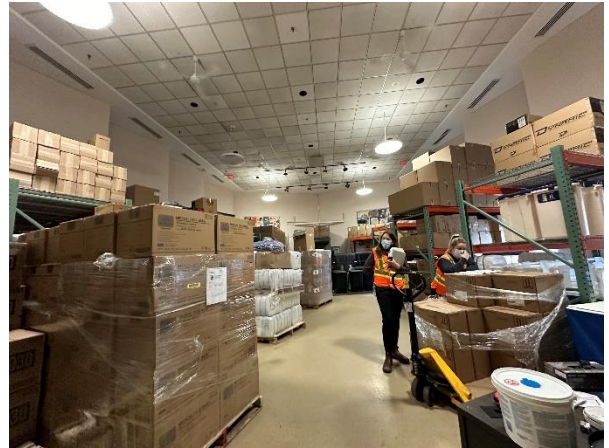
**Photograph No. 36** Chapel was noted to be used as a storage space.

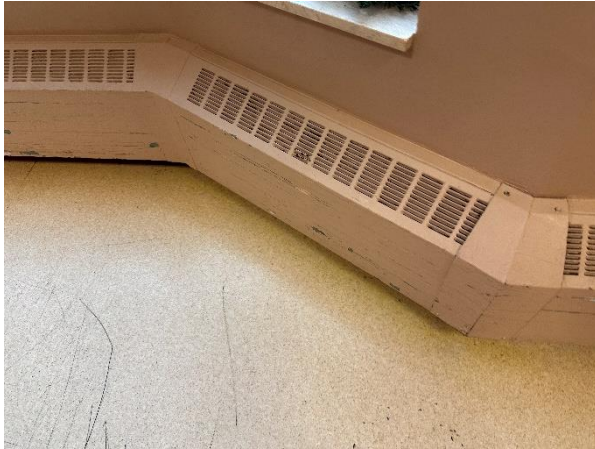
**Photograph No. 37** Scratched flooring and radiators.

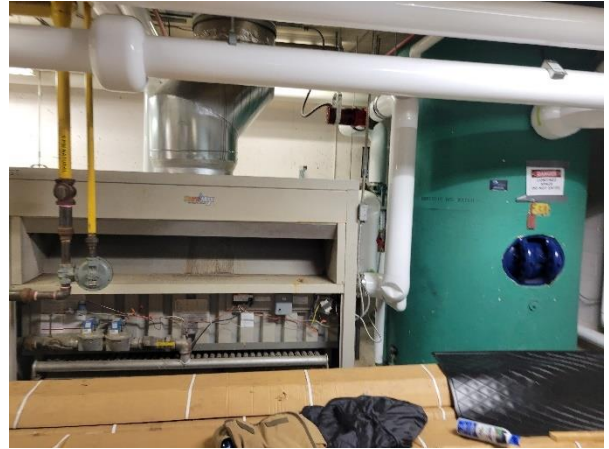
**Photograph No. 42** Domestic hot water heater and storage tanks are operational with repairs recently completed.

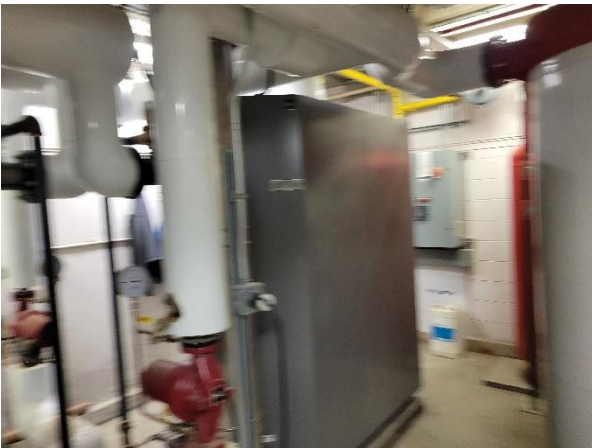
**Photograph No. 43** Heating boilers are new and in good condition.

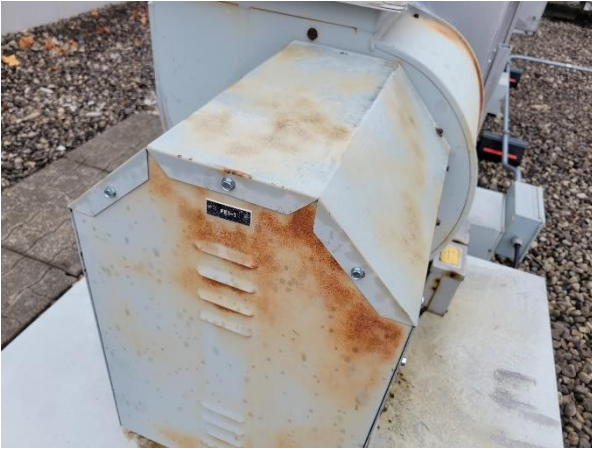
**Photograph No. 45** Rooftop exhaust fans are original but appear to be operational.

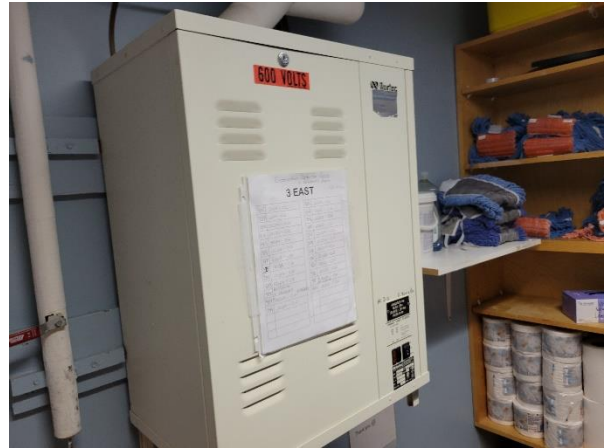
**Photograph No. 48** Humidifiers are reportedly not used.

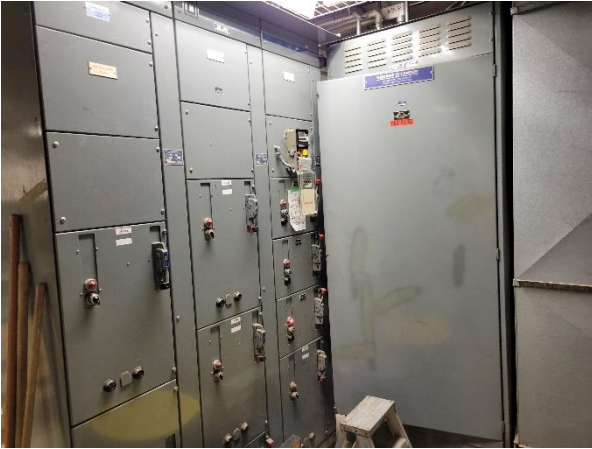
**Photograph No. 53** Open electrical panel noted in MPH.

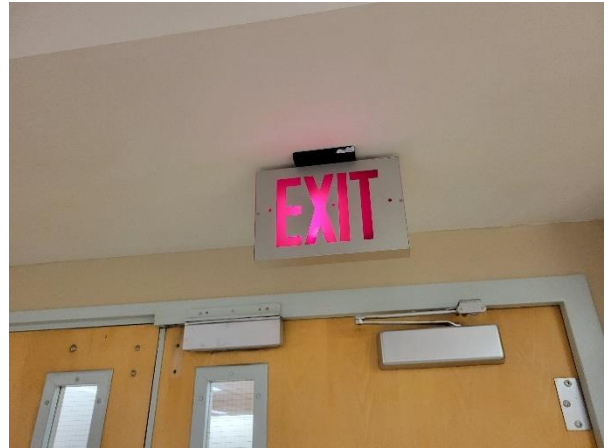
**Photograph No. 56** Exit lights are in fair condition.

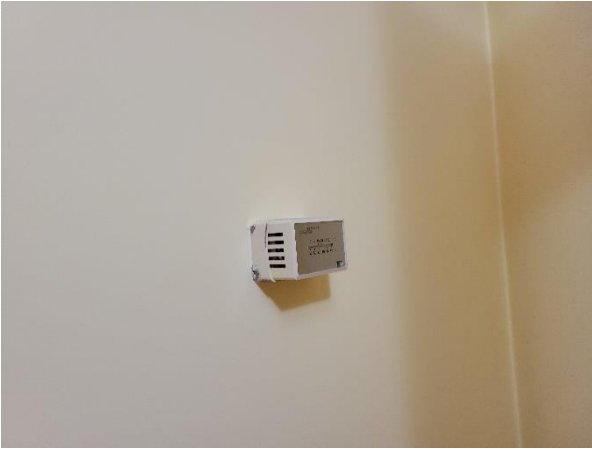
**Photograph No. 57** Thermostats are pneumatic but reportedly operational.

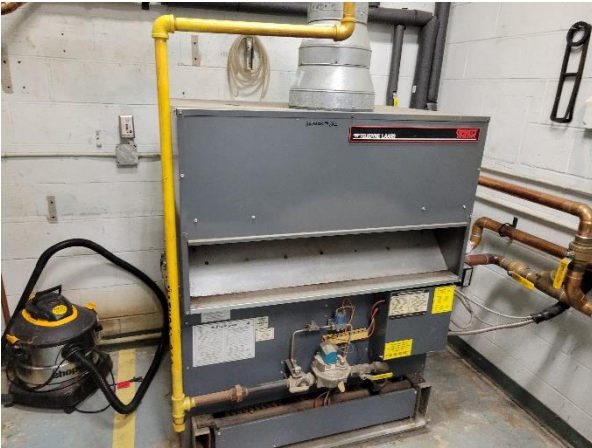
**Photograph No. 59** Laundry boiler is older and will require replacement based on service life.

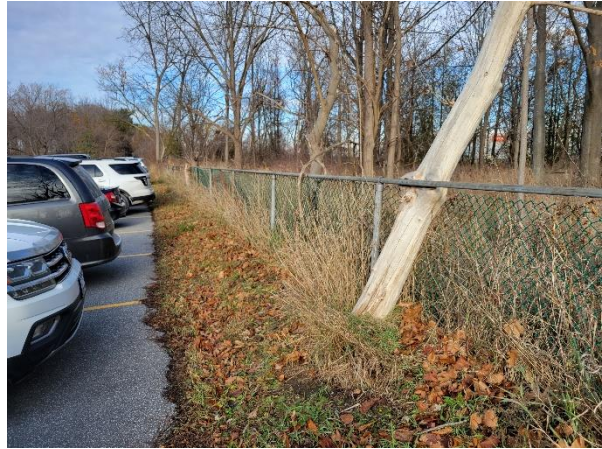
**Photograph No. 62** Perimeter chainlink fence is in fair condition with damages noted.

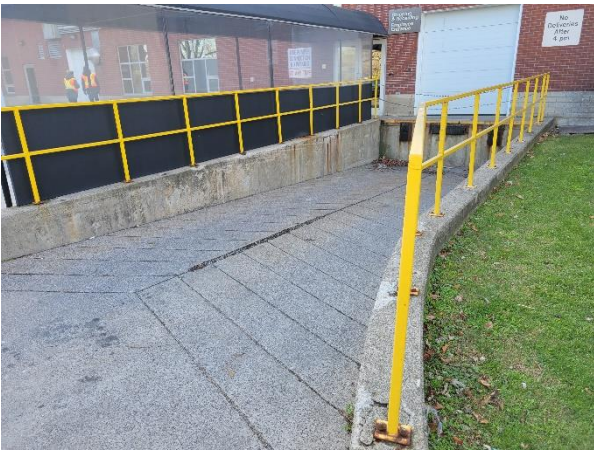
**Photograph No. 63** The loading dock ramp is in good condition with localized concrete damage noted.

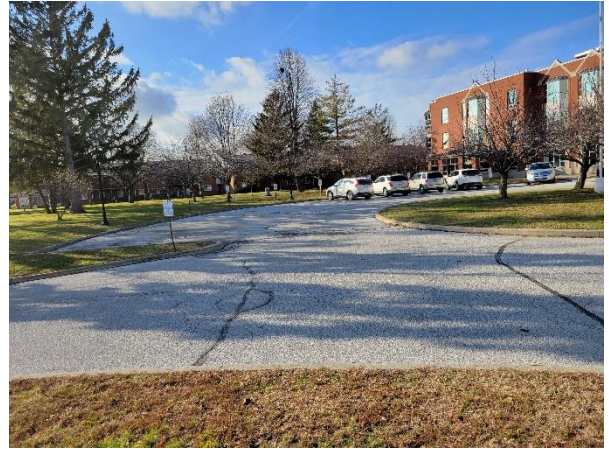
**Photograph No. 66** The south drive aisle is in fair condition with surface deterioration noted throughout.

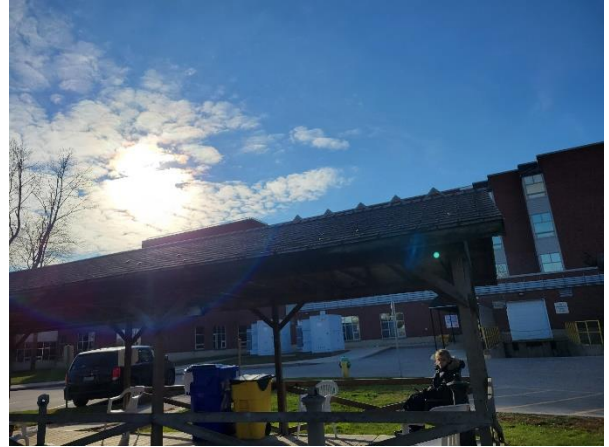
**Photograph No. 70** The staff outdoor gazebo is in fair condition with the shingles being in poor condition.
