BUILDING CONDITION ASSESSMENT FOR  
COUNTY OF ESSEX

**SUN PARLOR LONG TERM CARE  
HOME**

**175 TALBOT STREET EAST, LEAMINGTON**

REPORT DATE: May 29, 2024

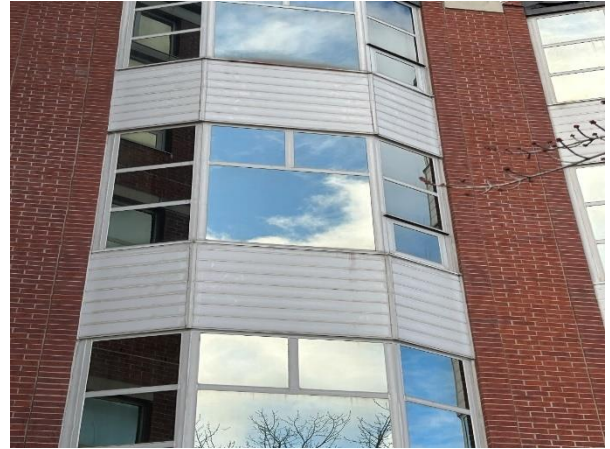
**Photograph No. 14** Typical window wall and metal siding configuration.

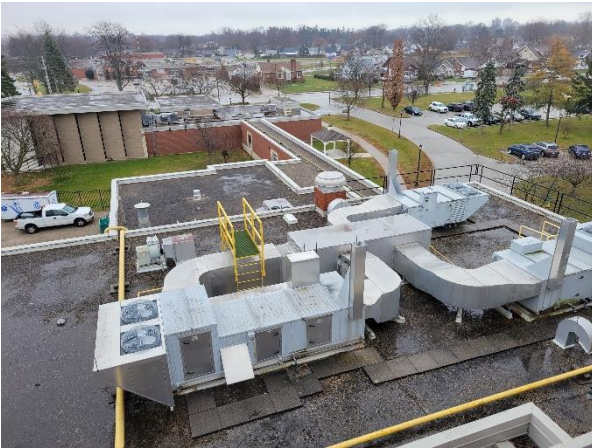
**Photograph No. 15** Ponding water along south roof areas.

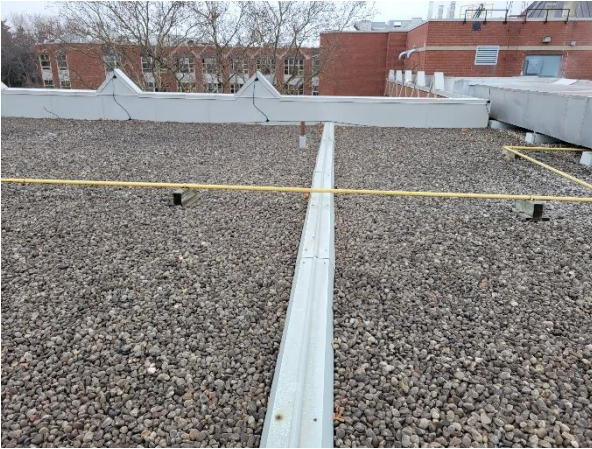
**Photograph No. 17** Expansion joint in inverted roofing system at main roof.

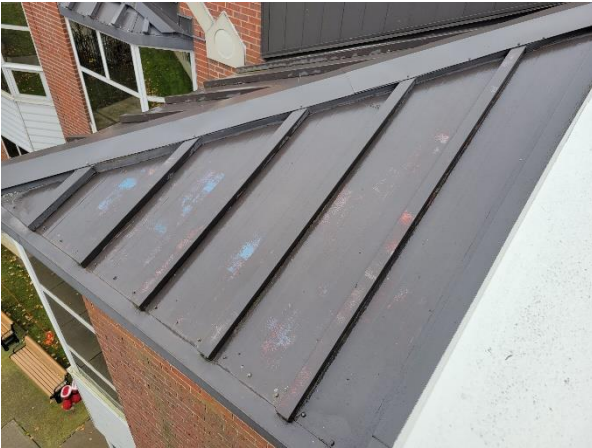
**Photograph No. 19** Discolouration at sloped metal roofing.

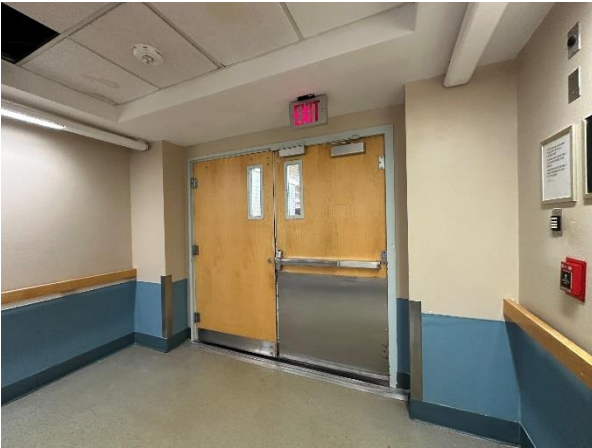
**Photograph No. 23** Typical interior wood doors.

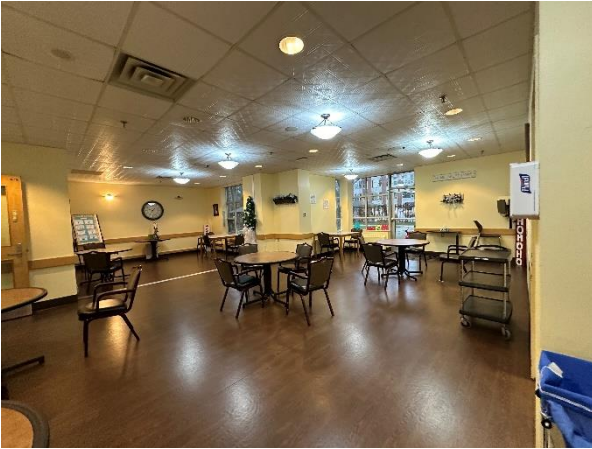
**Photograph No. 25** Typical dining room finishes are in good condition.

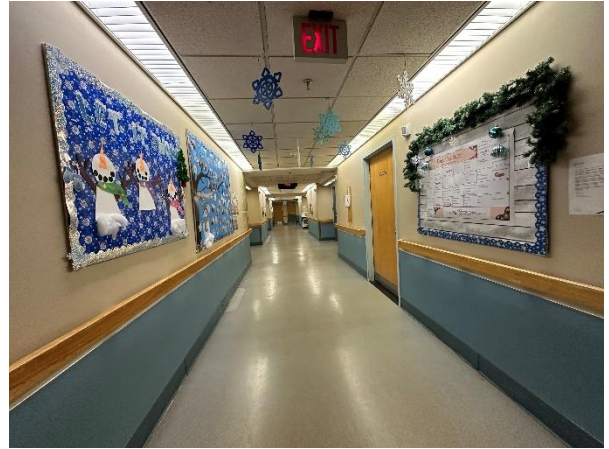
**Photograph No. 26** Typical corridor finishes are in good condition.

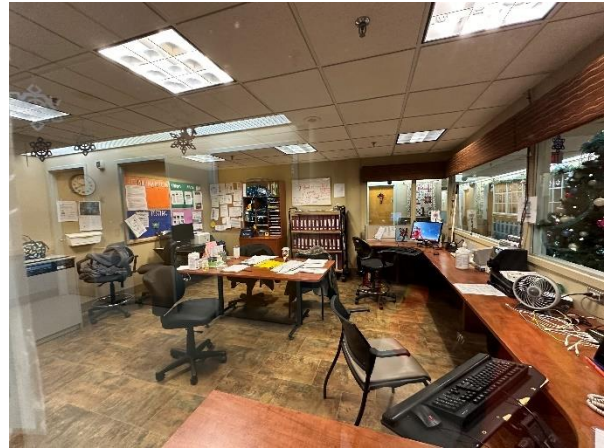
**Photograph No. 28** Typical administration room finishes are in good condition.

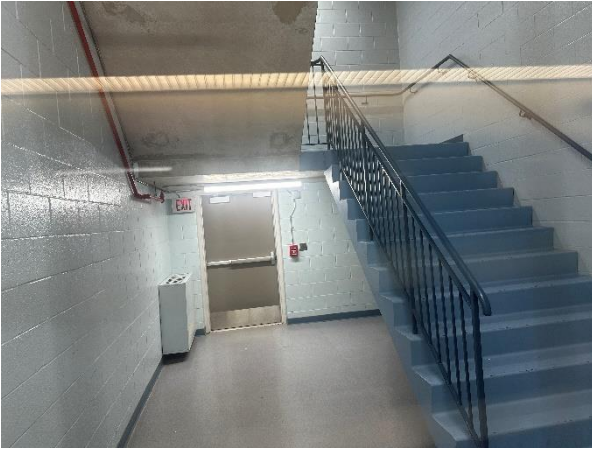
**Photograph No. 29** Typical stairwell finishes are in good condition.

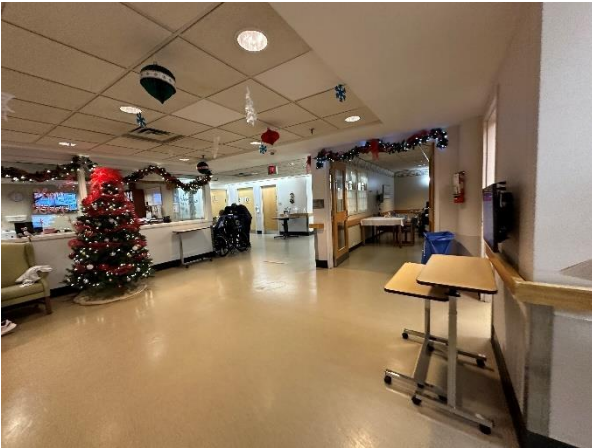
**Photograph No. 31** Typical open area finishes are in good condition.

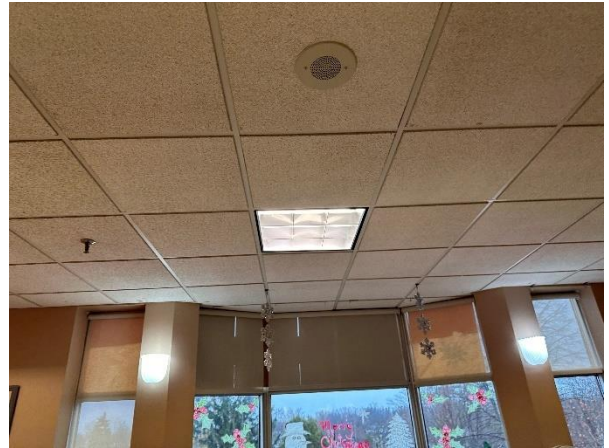
**Photograph No. 32** Drop ceiling finishes are generally in good condition.

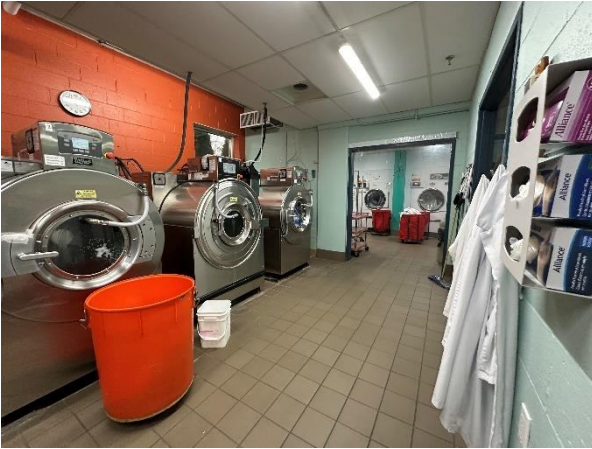
**Photograph No. 33** Laundry room finishes, and equipment are in good condition.

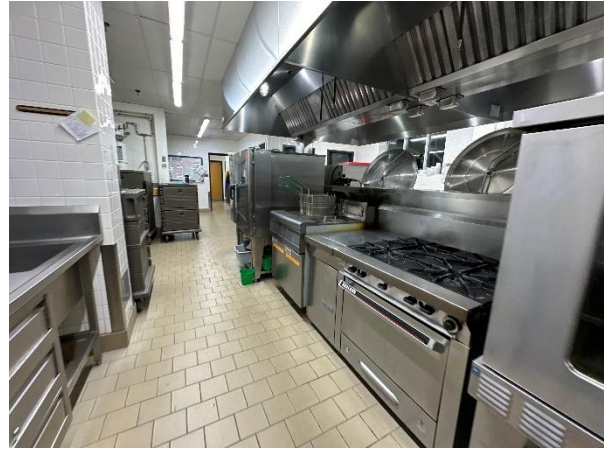
**Photograph No. 34** Kitchen finishes and appliances are generally in good condition.

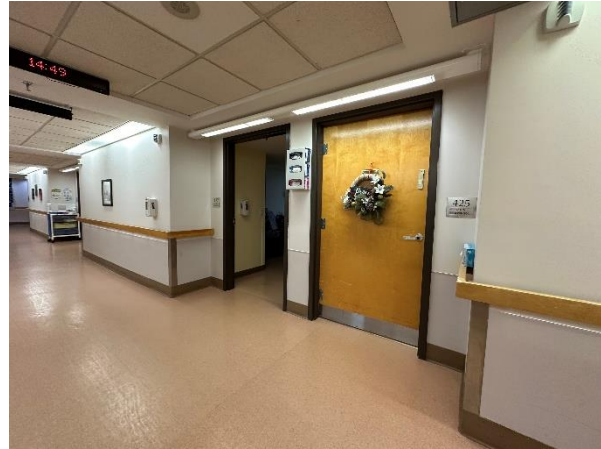
**Photograph No. 38** Solid wood resident room doors.

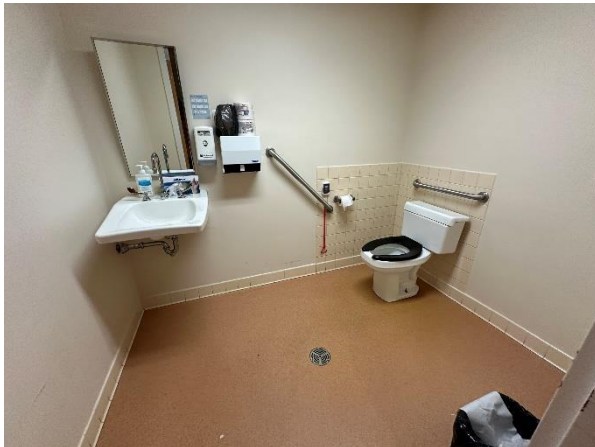
**Photograph No. 39** Resident room washroom.

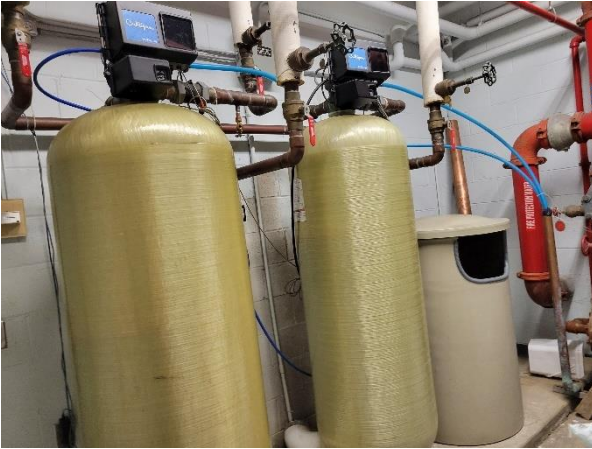
**Photograph No. 41** Domestic cold water is treated with a softening system.

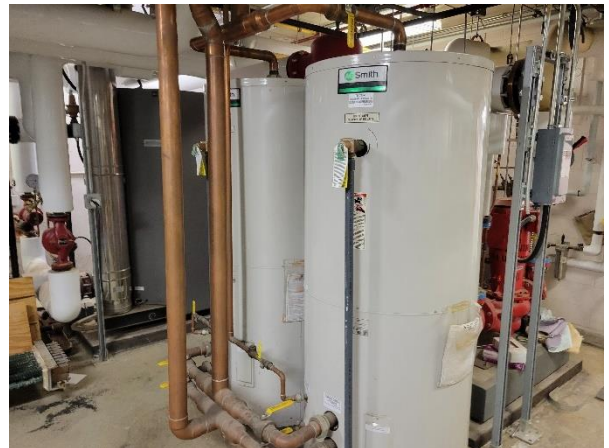
**Photograph No. 44** Back-up DHW tank heaters are in good condition.

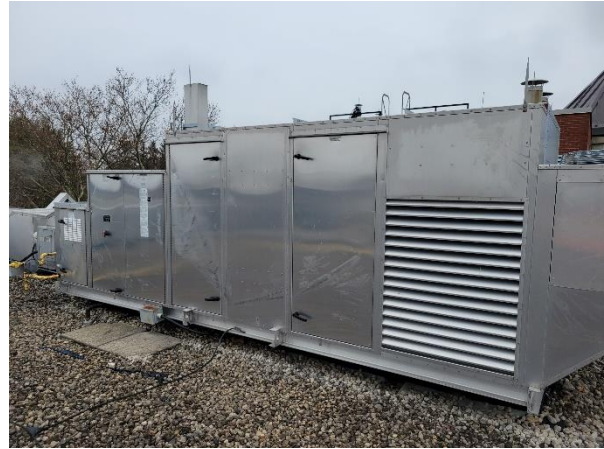
**Photograph No. 46** All air handling units are new and in good condition.

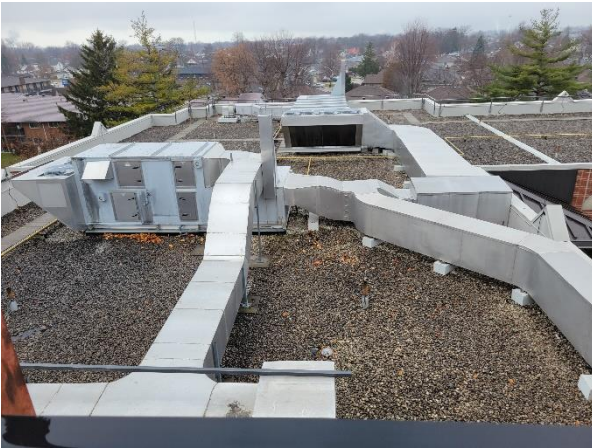
**Photograph No. 47** All air handling units are in good condition.

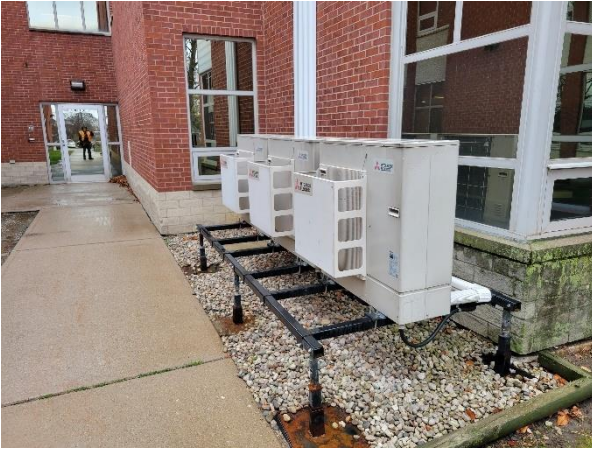
**Photograph No. 49** Exterior condenser units are new and in good condition.

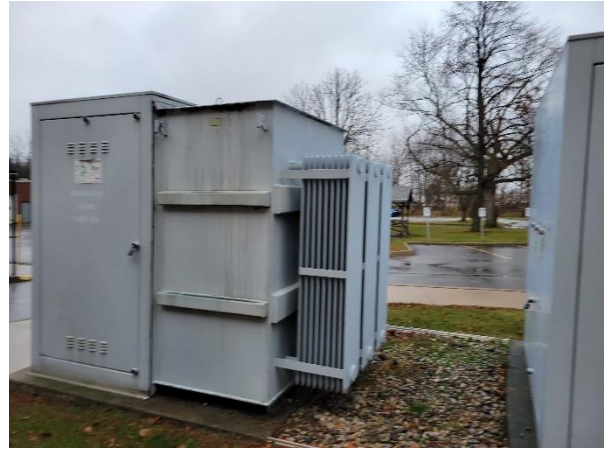
**Photograph No. 50** Main power is supplied from pad mounted transformers.

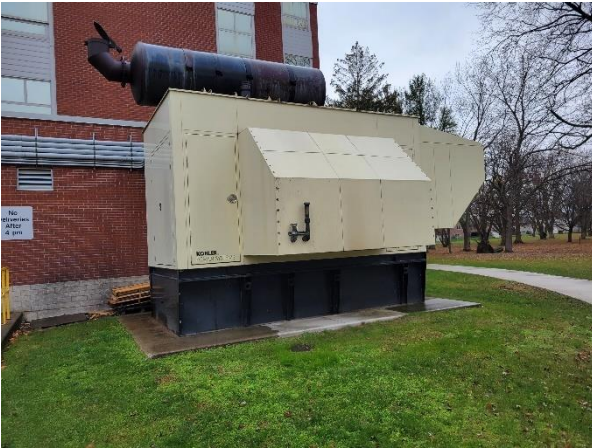
**Photograph No. 51** Diesel generator appears to be in good condition with no issues reported.

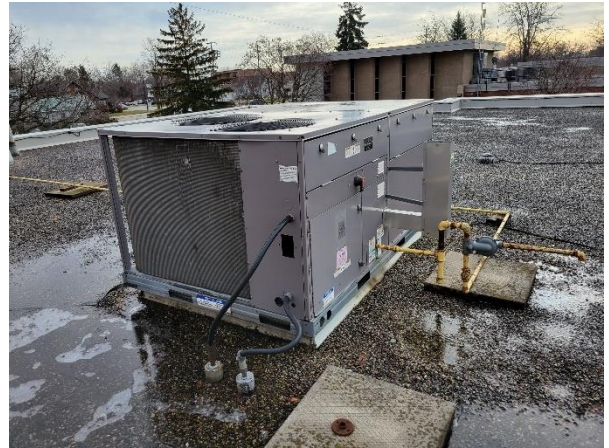
**Photograph No. 52** South wing package rooftop units are in good condition.

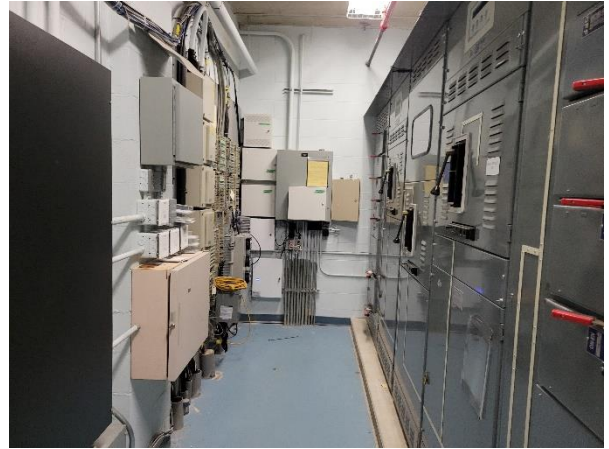
**Photograph No. 54** Main electrical distribution equipment is in good condition.

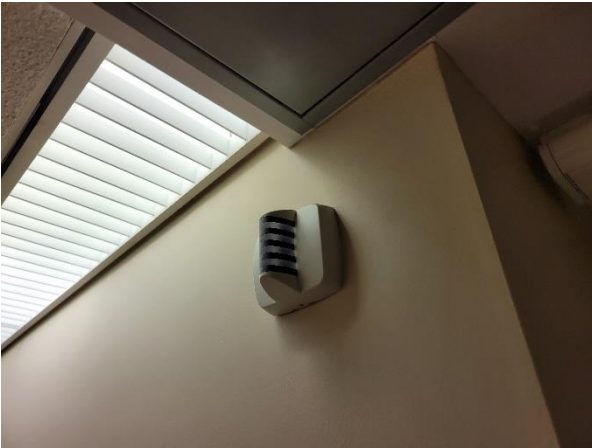
**Photograph No. 55** Nurse call system is new and in good condition.

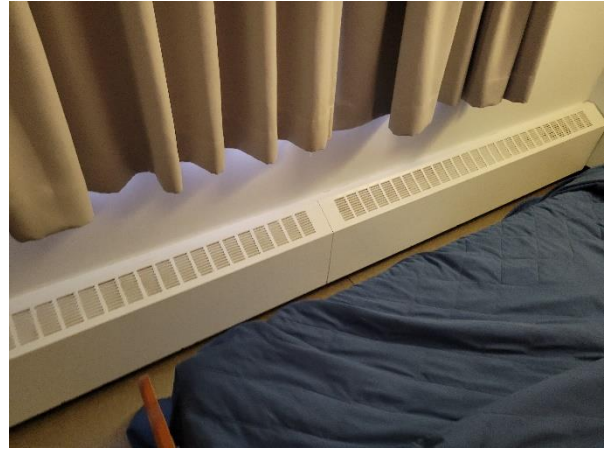
**Photograph No. 58** Radiators throughout are generally in good condition.

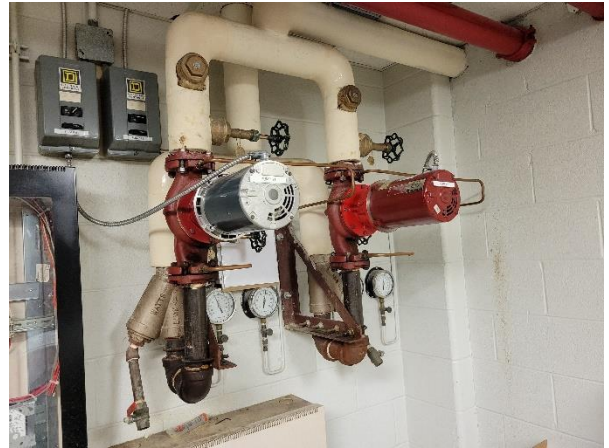
**Photograph No. 60** Circulation pumps for the south wing heating loops appear to be operating normally.

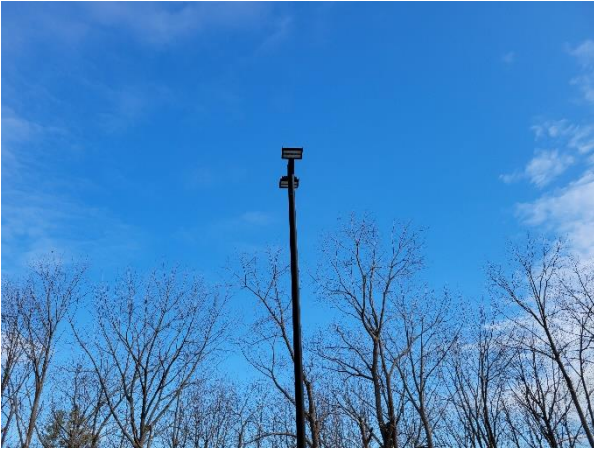
**Photograph No. 61** Lamp standards with new LED lamps are in good condition.

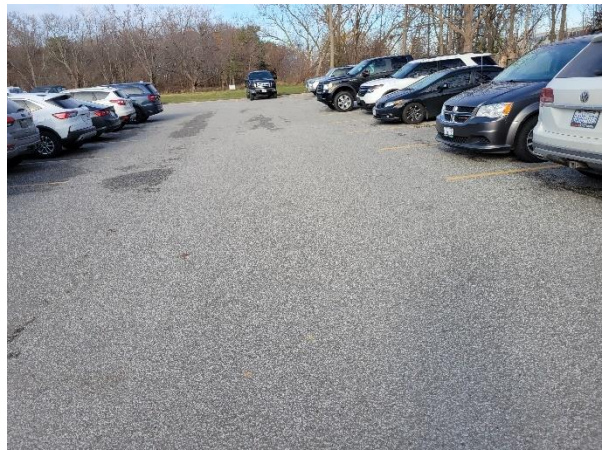
**Photograph No. 64** Paved asphalt parking areas are in good condition.

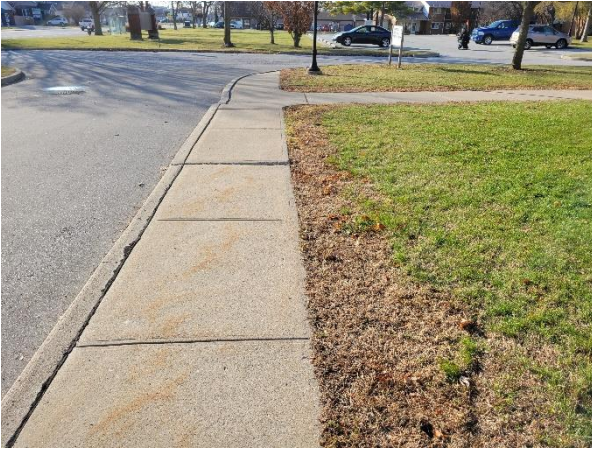
**Photograph No. 65** Walkways are generally in good condition.

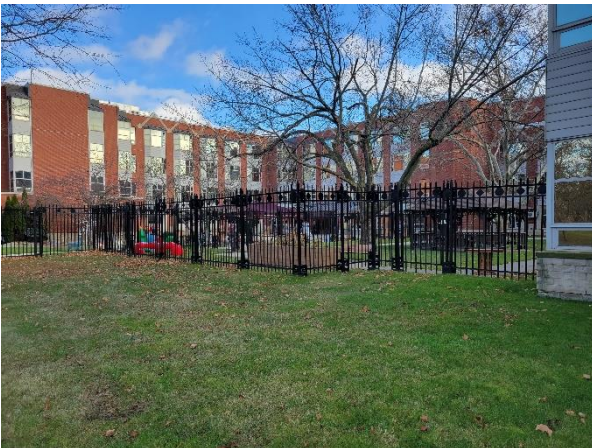
**Photograph No. 67** Metal fencing around the rear outdoor area is in good condition.

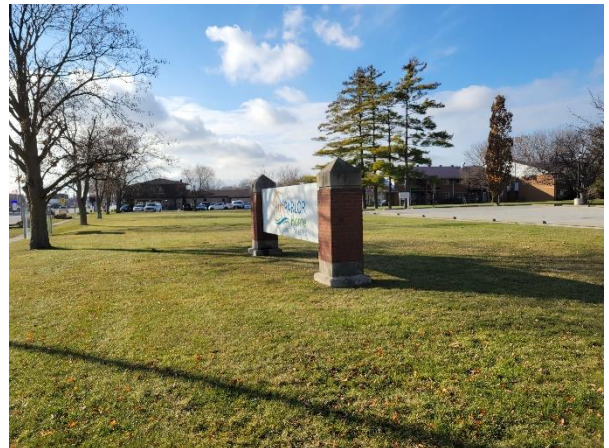
**Photograph No. 68** Main entrance sign is in good condition.

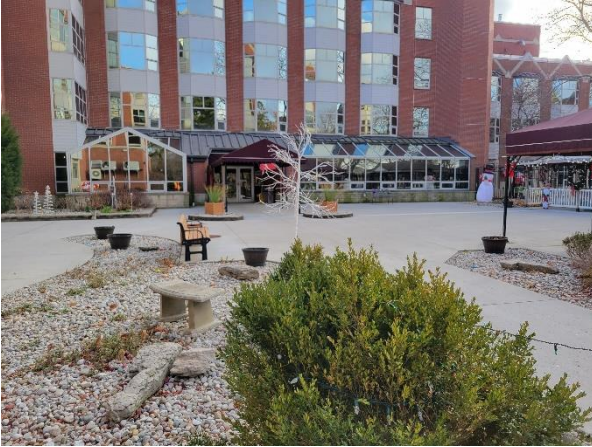
**Photograph No. 69** Rear concrete surfaces are generally in good condition.

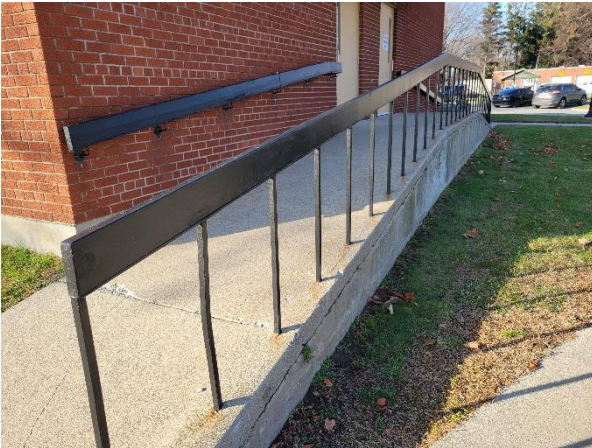
**Photograph No. 71** South wing exit ramp is in good condition.

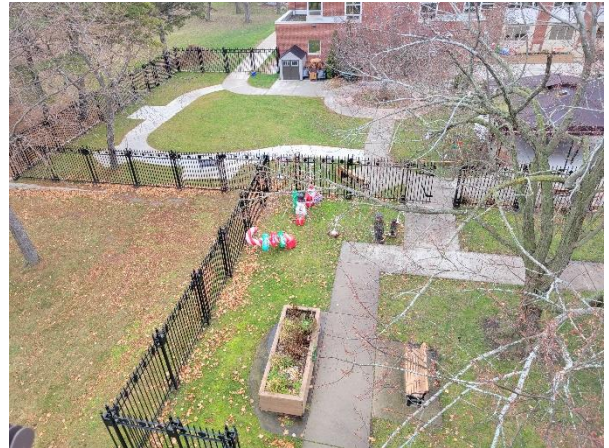
**Photograph No. 72** Landscaping throughout is generally in good condition.
