BUILDING CONDITION ASSESSMENT FOR  
COUNTY OF ESSEX

**SUN PARLOR LONG TERM CARE  
HOME**

**175 TALBOT STREET EAST, LEAMINGTON**

REPORT DATE: May 29, 2024

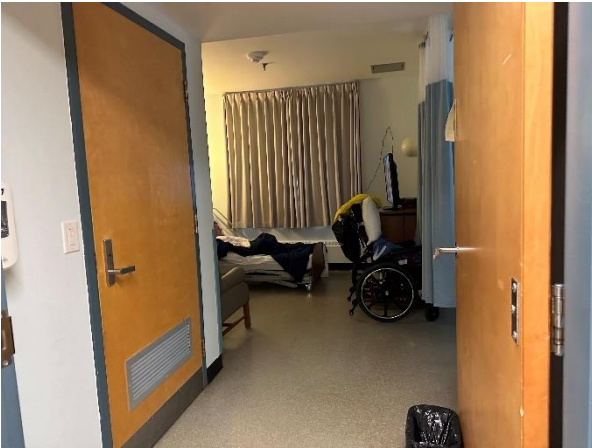
**Photograph No. 27** Typical resident room finishes are in good condition.

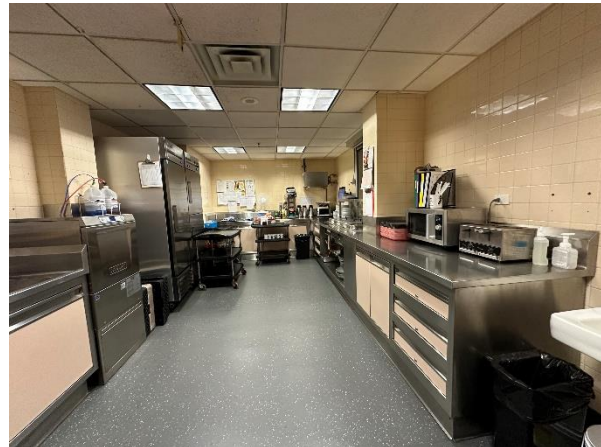
**Photograph No. 40** Serveries located in each resident wings.
